June 18, 2025

RE: Summary of 2025 Inspection, Brandon Solid Waste Facility Engineer's Evaluation, Brandon Landfill SWF ID# RU080

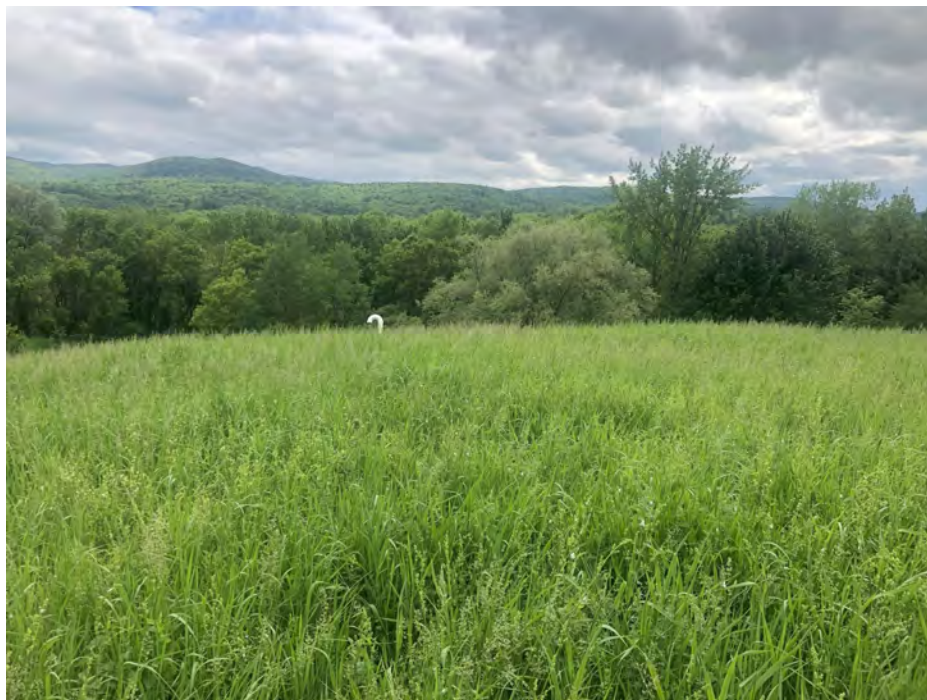
Photo 1 (looking north): Landfill crest with dense vegetative growth on landfill cap.

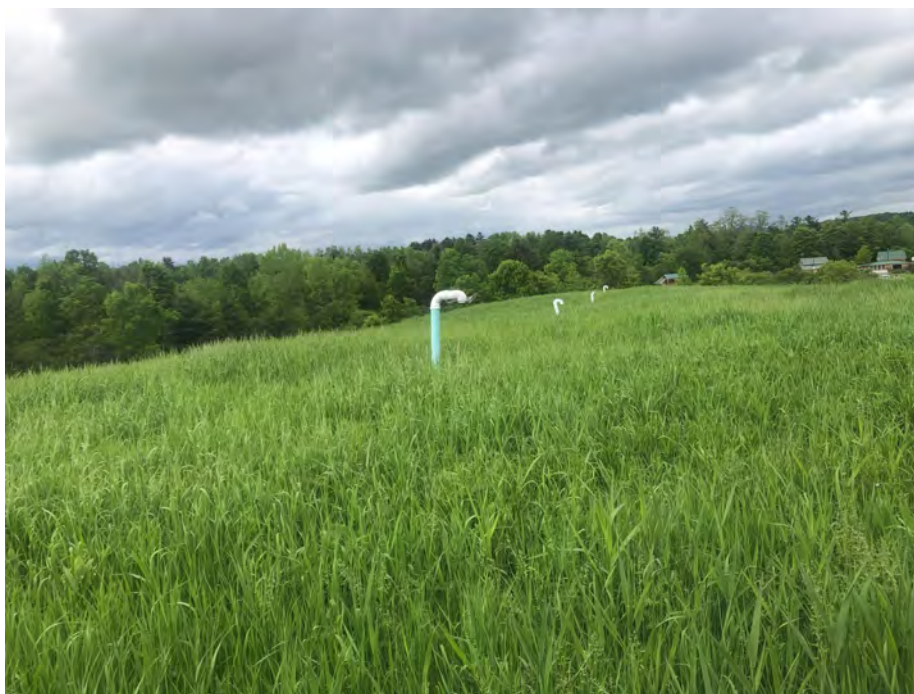
Gas Control Systems - The landfill gas vents are located on the crest of the landfill. All the gas vents observed were found to be in fair to good condition, and no repairs are recommended at this time.

Photo 2 (looking north): Looking north along landfill crest at gas vents in fair condition.

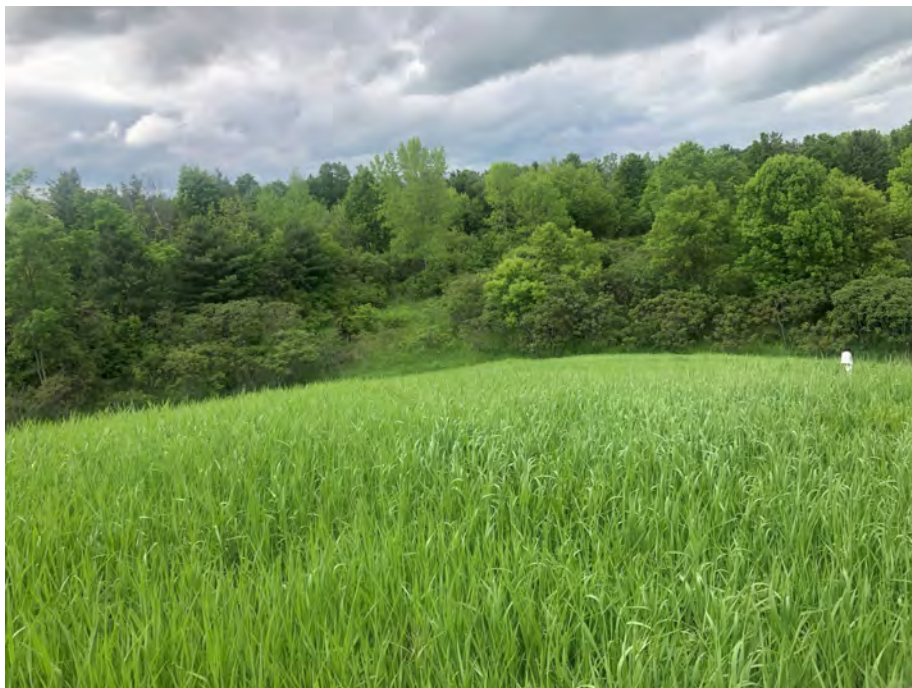
Photo 3 (looking north): North face of closed landfill with robust dense vegetative cover in good condition.

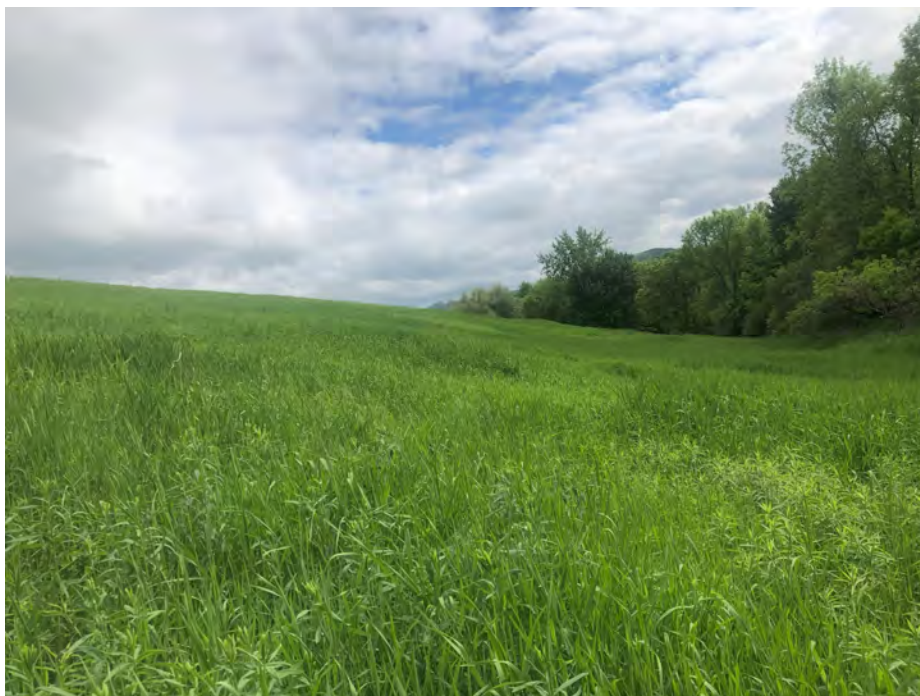
Photo 4 (looking south): West face of closed landfill in good condition.

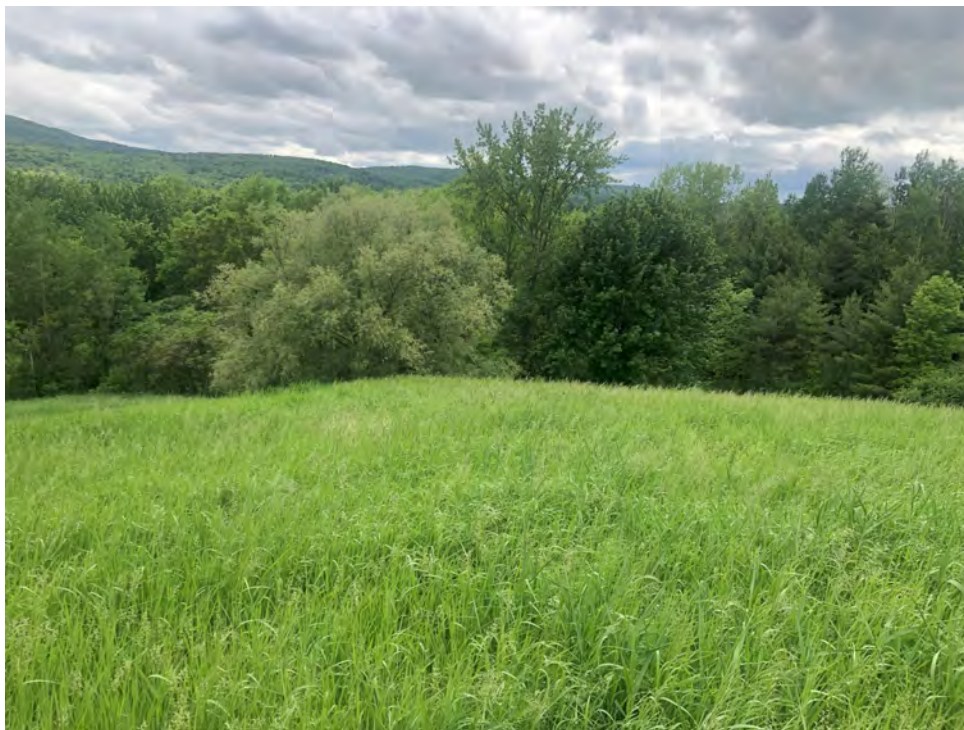
Photo 5 (looking south): South face of closed landfill in good condition.

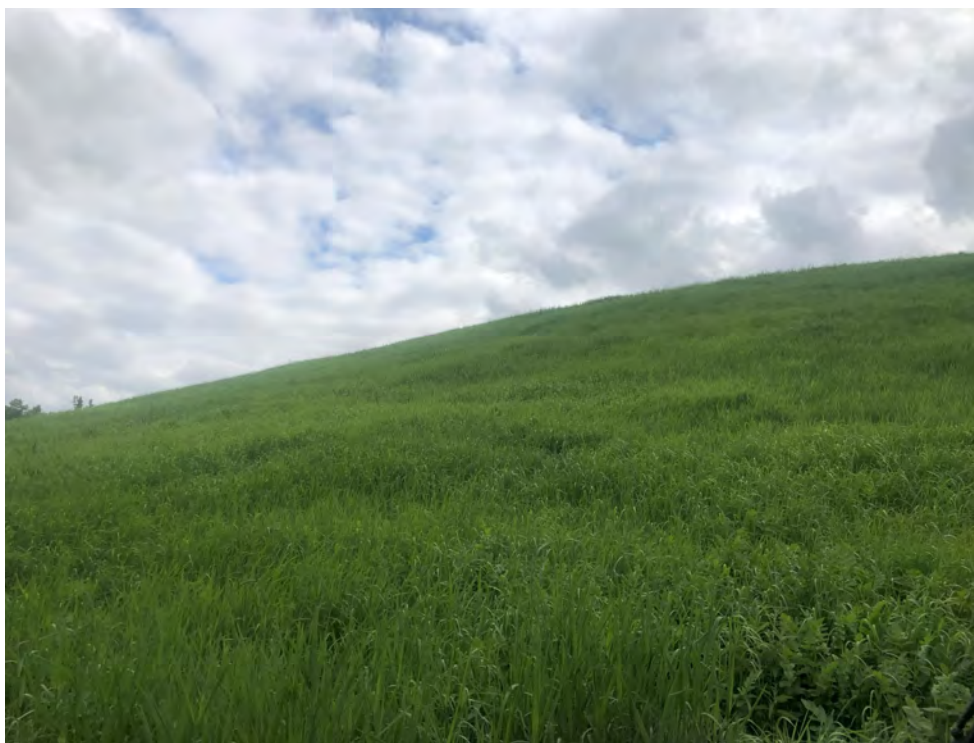
Photo 6: East face of closed landfill in good condition.

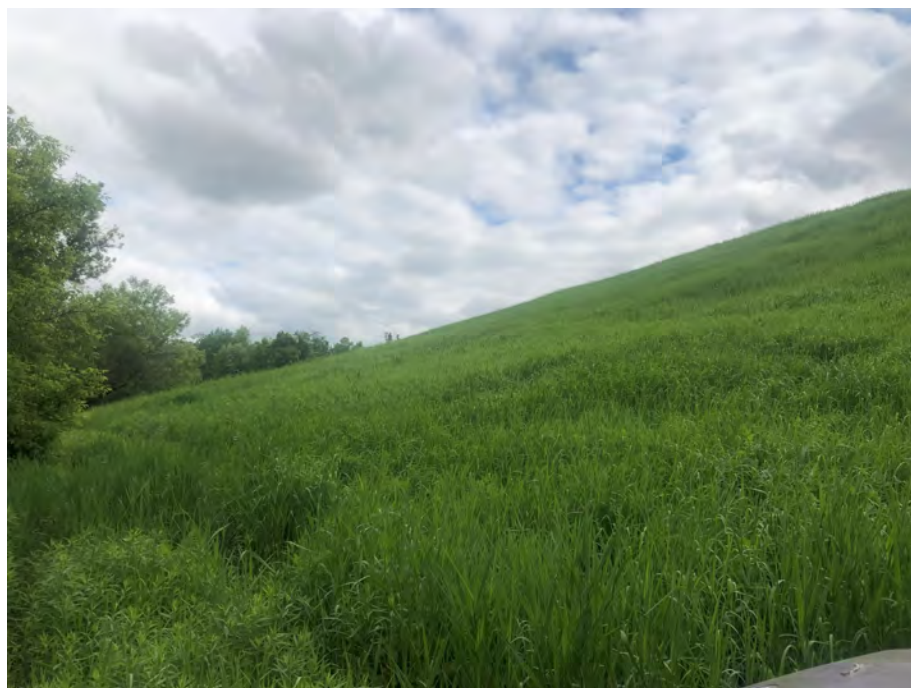
Photo 7: East face of closed landfill observed to be in good condition.
