Neshobe River Overview

And Explanation of River Corridor Easements

Ethan Swift 8-28-17

RIVERS PROGRAM

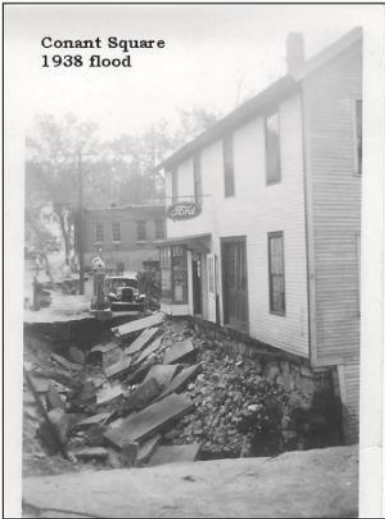
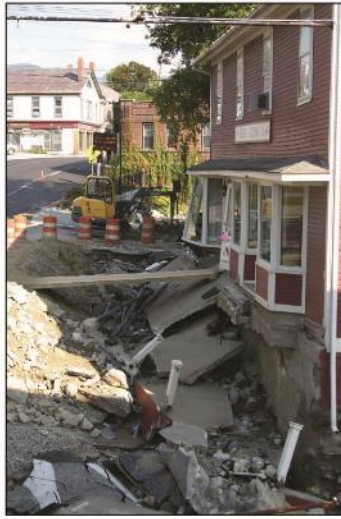
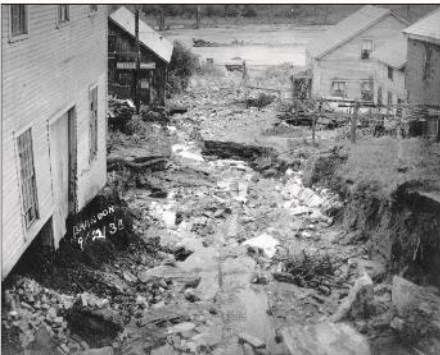
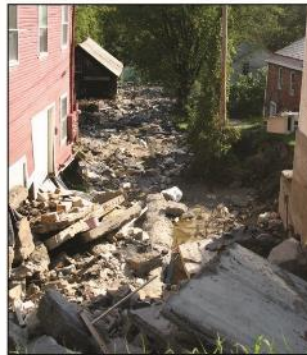
Conant Square
1938 flood

The damaged from the 1938 flood is eerily similar to the devastation of the Aug. 28, 2011 torrent.

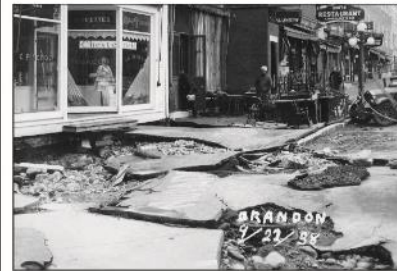
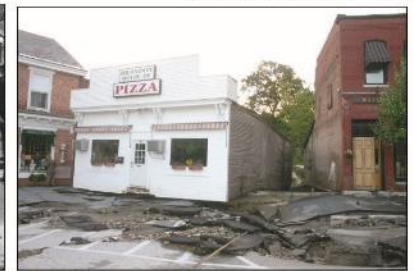
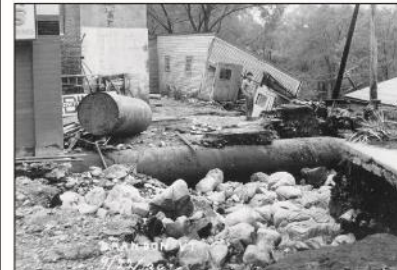
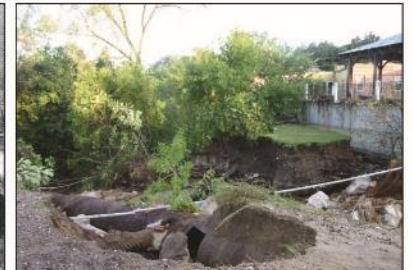
At left, the destruction around the Briggs' Carriage Building from the 1938 flood, and above, right, the damage incurred from Aug. 28, 2011 flood. Below, left, Briggs Lane after the 1938 flood, and below right, Briggs Lane. Above, top photos, Center Street's pavement and sidewalk crumbled after the Noshobe River flooded through downtown in 1938, and did the same thing on Aug. 28. Bottom photos, the penstock and water main left exposed next to what is now Liza Myers' gallery in 1938, and today, next to Green Park.

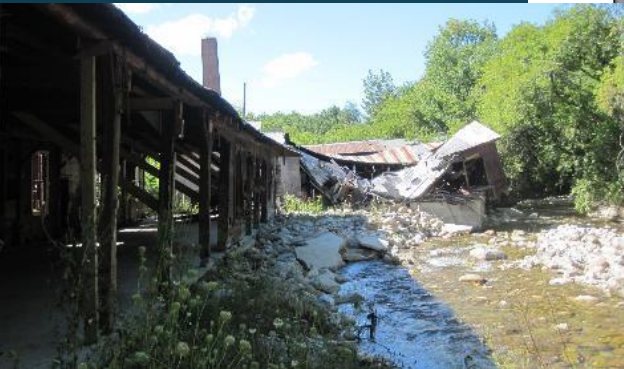
Tubbs Building berm removal

Newton Rd Berm Removal Analysis Brandon, Vermont
