**REPORT ON
GEOTECHNICAL DATA REPORT
TWO-SPAN STONE ARCHES BRIDGE NO. 114
US ROUTE 7 OVER THE NESHOBE RIVER
BRANDON, VERMONT**

by Haley & Aldrich, Inc.
Bedford, New Hampshire

for CLD Consulting Engineers, Inc.
Manchester, New Hampshire

File No. 41107-100
September 2015

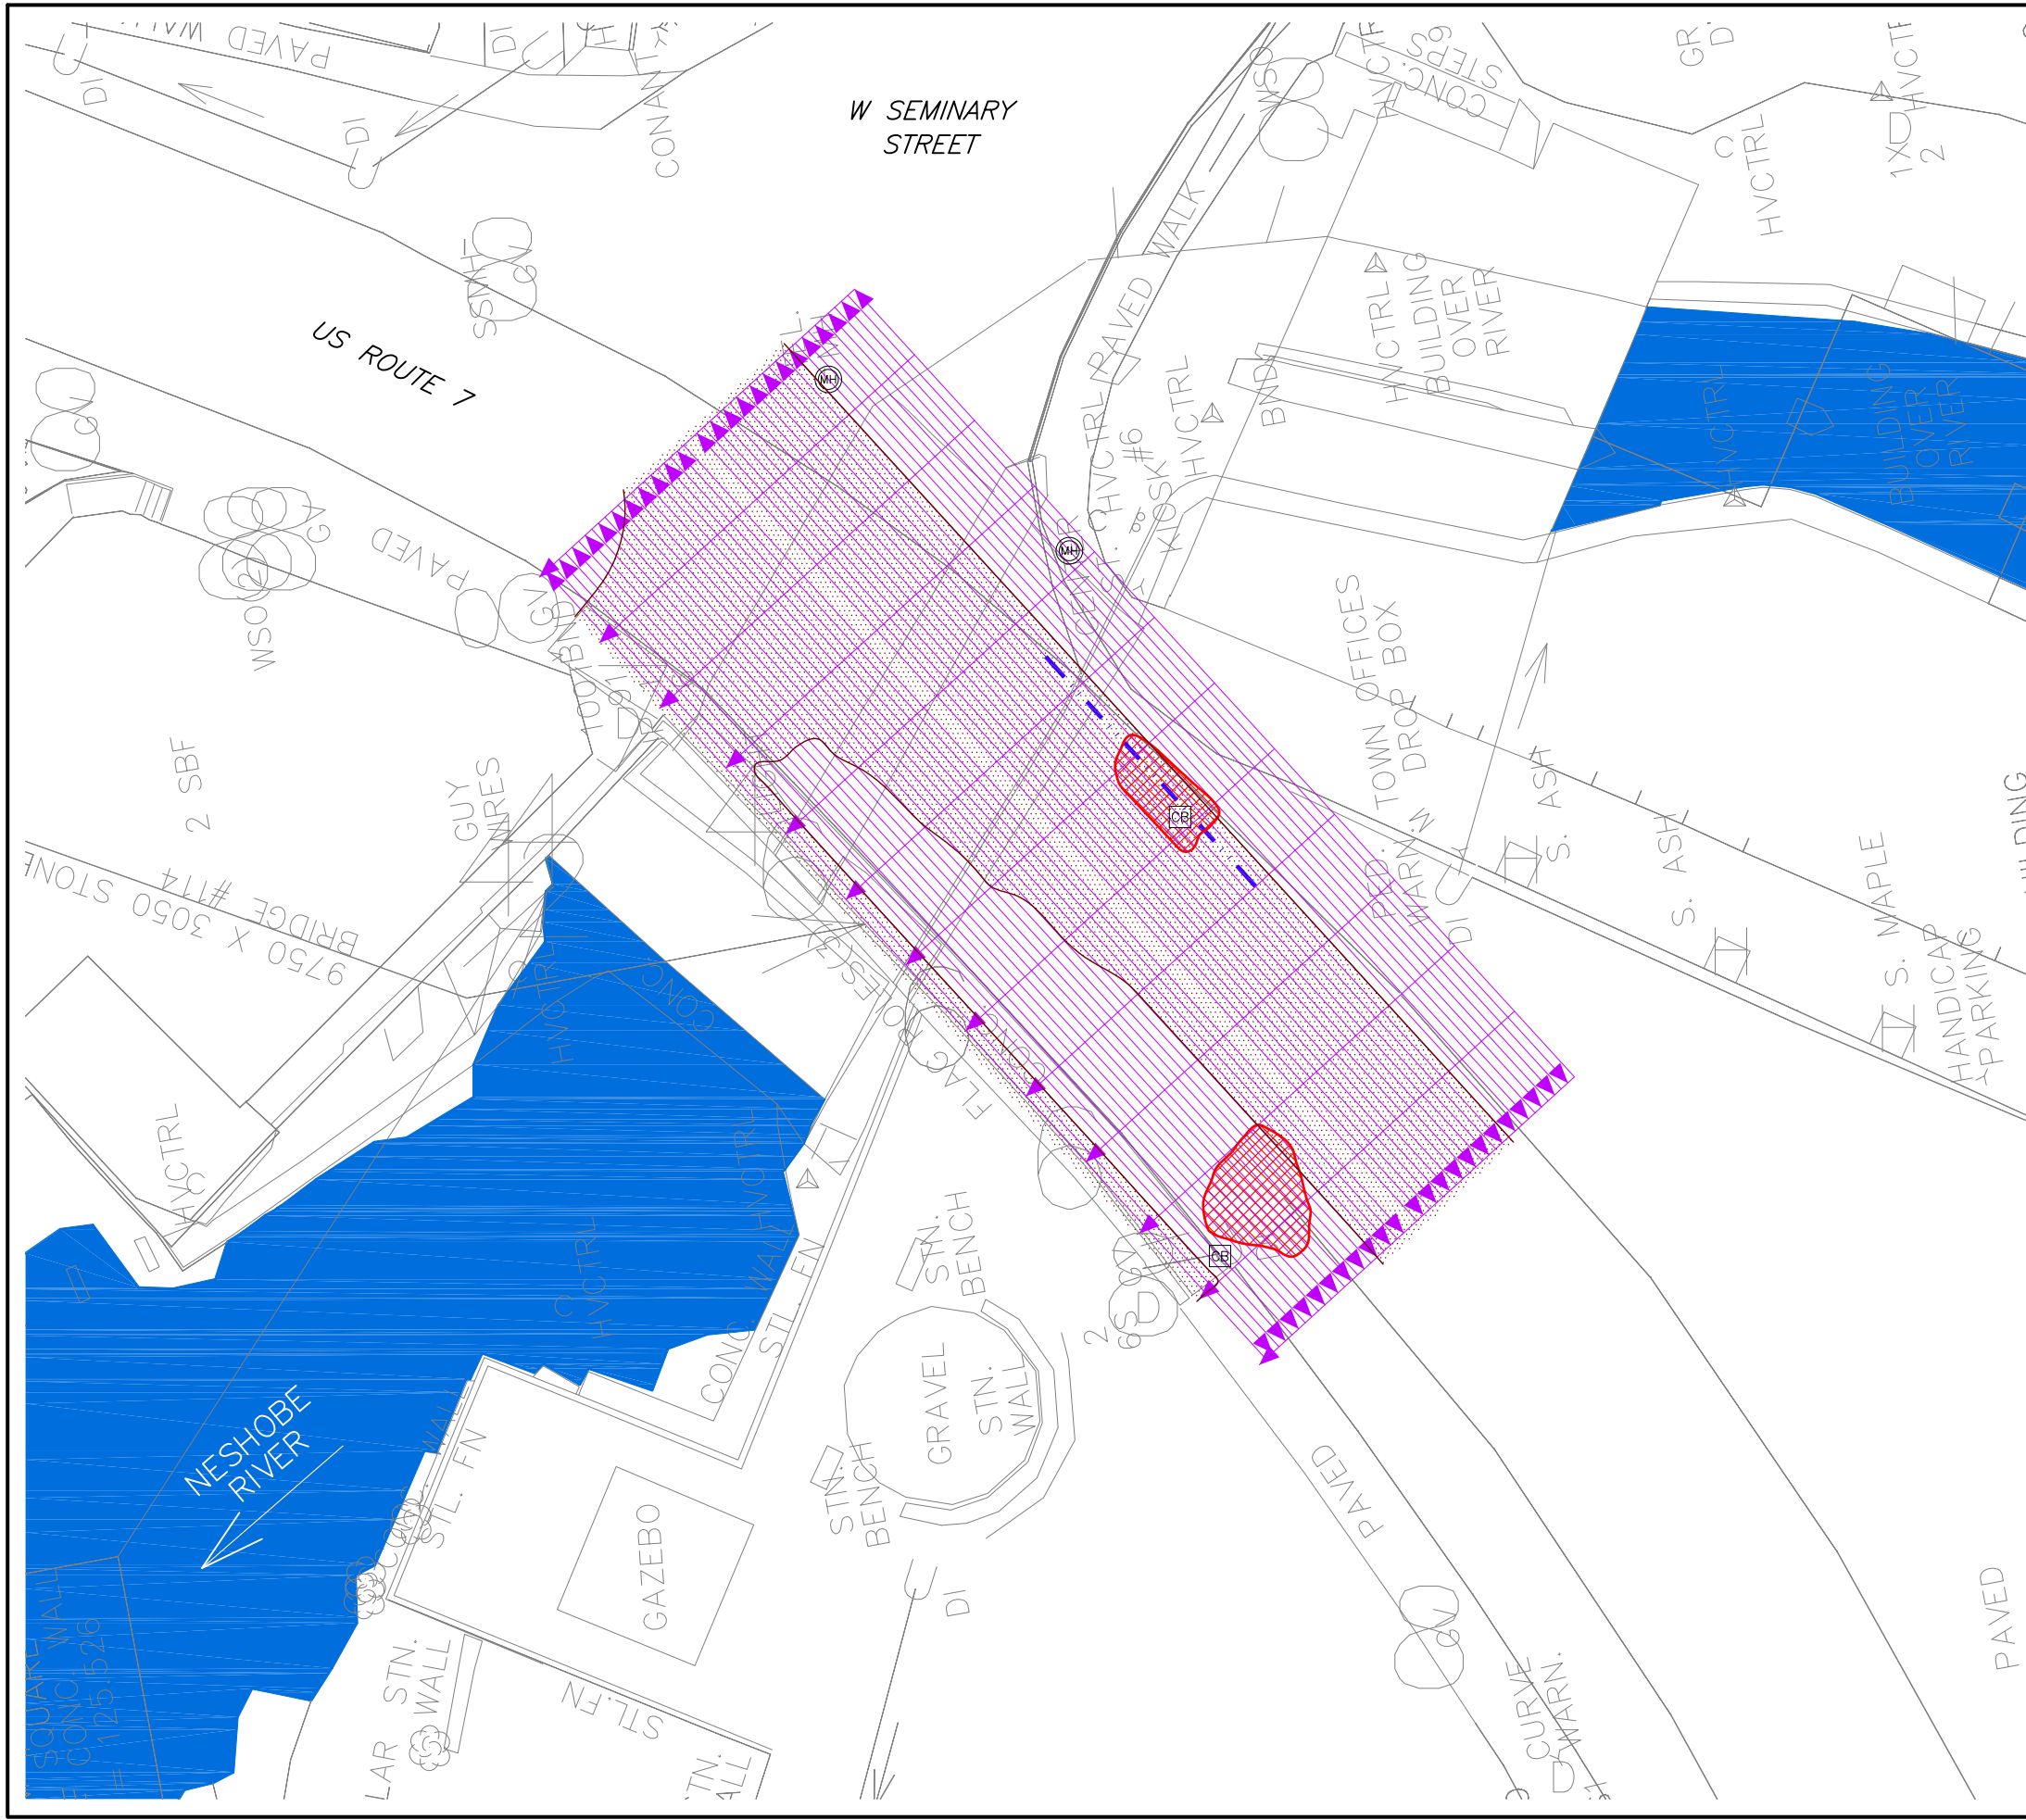
Figure 3 GPR Survey US Route 7 Bridge Over Neshobe River Brandon, Vermont	
File 15SG11	July, 2015
HAGER-RICHTER GEOSCIENCE, INC. Salem, New Hampshire

- GPR TRAVERSE
- PORTION OF GPR TRAVERSE SHOWN IN FIGURE 4
- AREA OF POSSIBLE DISTURBED SOILS
- REINFORCED AREA
- MANHOLE
- CATCH BASIN

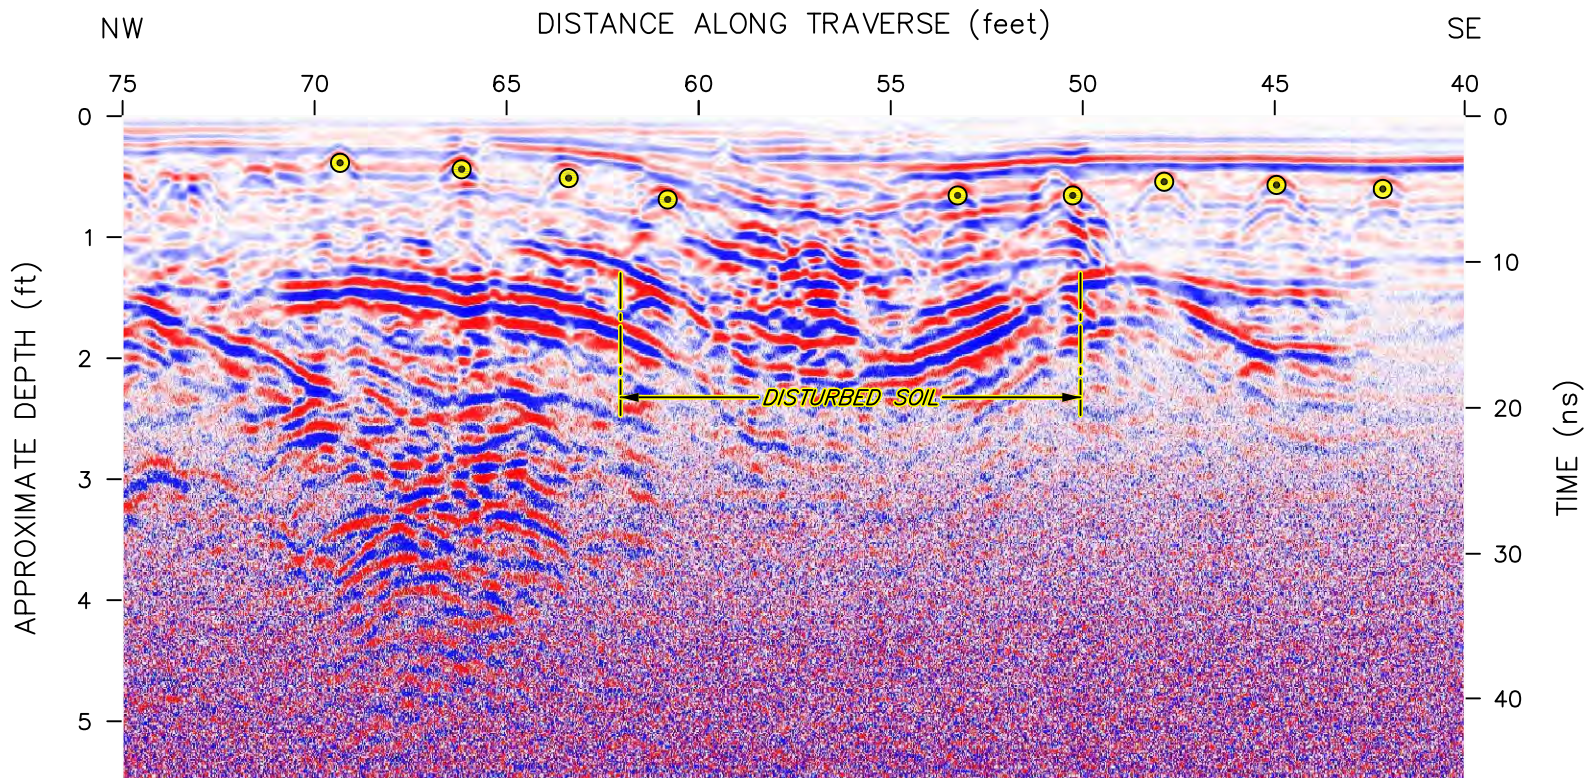
1. GPR data were acquired using a GSSI UtilityScan DF digital dual-frequency system using both 300MHz & 800 MHz antennas with 90 ns & 45 ns time windows, respectively. 800 MHz data shown above.
2. Location of GPR record shown in Figure 3.
