**Brandon Select Board Meeting**  
**August 12, 2019**  
**7:00 p.m.**

**SCOPING STUDY**  
**FOR**  
**WEST SEMINARY STREET STRUCTURE**  
**BRANDON, VT**

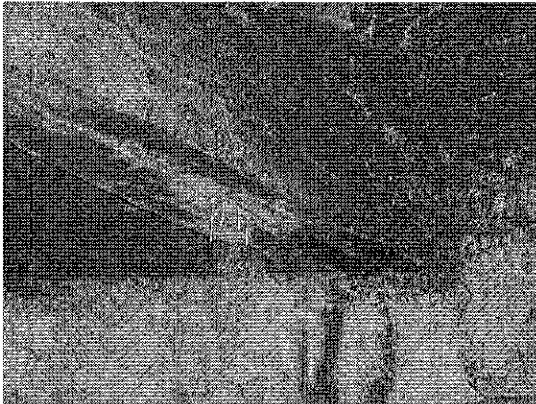
- Beams 3 and 4 of the Structure are in poor condition with large spalls along the bottom of the beam, full length longitudinal cracks along the full length of each beam, and extensive delamination along the lengths of the cracks. Beam 4 has what appears to be the bottom of two railroad tracks exposed at the bottom of it due to spalled off concrete. There also appears to be a railroad track on the top of the beam. In addition, at the end of the beam where it is supported along the wall, a 45 degree crack extends from the bottom of the beam upwards. This type of crack is indicative of a possible shear failure. Beam 3 is in similar condition to Beam 4 except the concrete spall at the end of the beam has not yet separated, however, cracks and delamination in that area indicate that the spall will break loose imminently. No steel reinforcement is evident in any of the spalls.

Possible Railroad Tracks Exposed in the Bottom of Beam 4

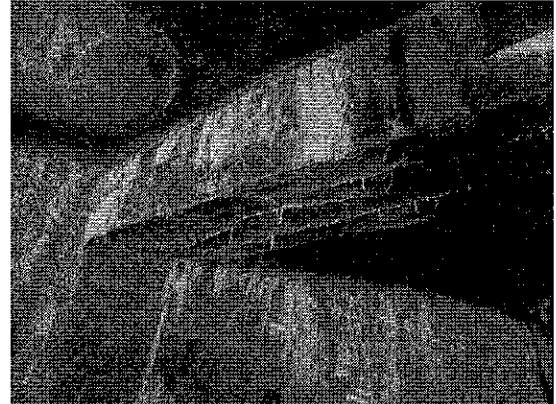
Cracking and Efflorescence in the Bottom of Beam 3

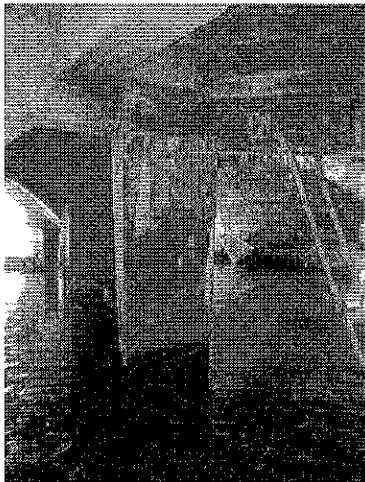
Left: View Looking Downstream at Center Column with the Ends of Beams 3, 4, 5, and 6 shown (right to left); Right: Connection of Beams into Center Column

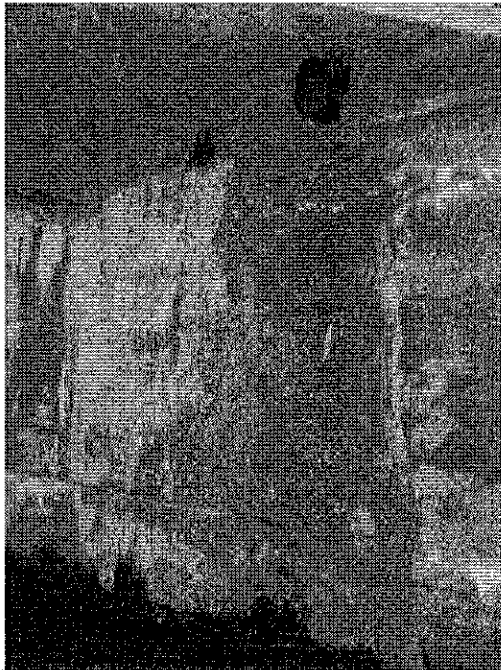
The geometry and configuration of the walls are unknown, however, there is no evidence of rotating, bulging, cracking or settlement that would indicate they are failing. However, the walls do have extensive spalling, delaminations, and concrete deterioration along the waterline, as well as spalling and delamination underneath two existing drainage pipes. These pipes have been abandoned and are no longer connected to a drainage system, however, there is significant water leakage through the lower part of the concrete walls in some locations.

Spalling of North Wall below Drain Pipe

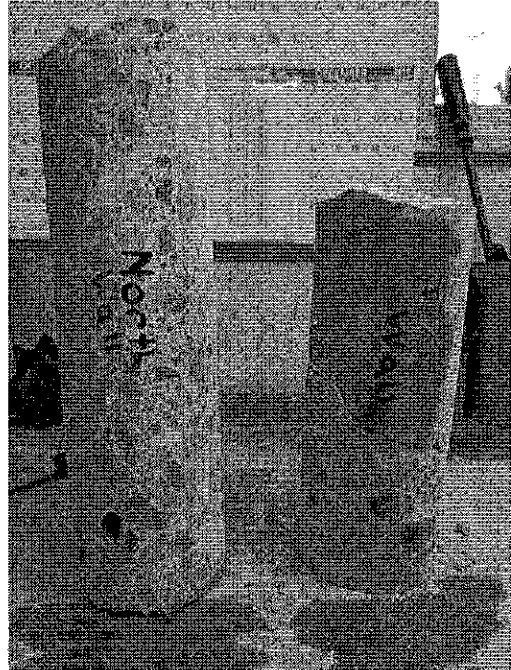
- The wall cores indicate several inches of concrete along the west wall with stone behind it, whereas the north wall went a full 14 inches through concrete without encountering stone. A compression test completed using the core from the North Wall showed competent concrete strength of 6,066 psi. Please refer to the compression test results in Appendix B. At this time, the petrographic tests are not available yet, therefore a complete assessment of the concrete cannot be made.

Concrete Cores of Walls

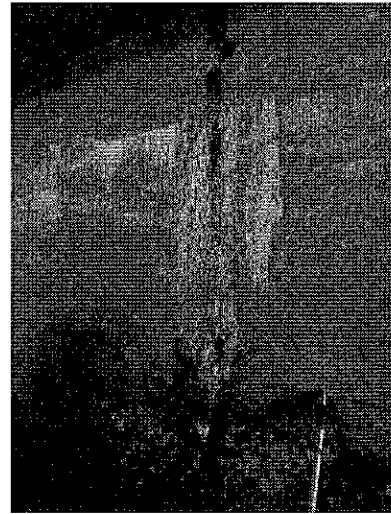
Spalling Below Abandoned Drain Pipe

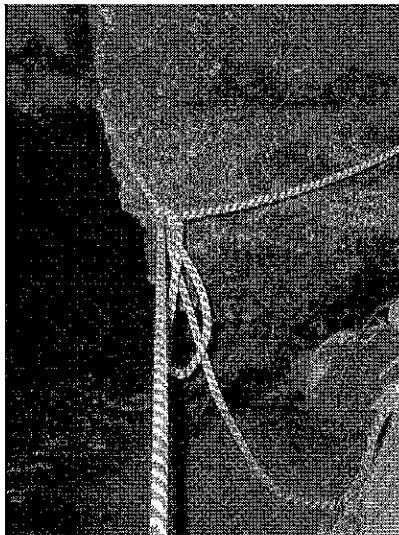
- The center column supporting the majority of the beams is undermined for the full width of the column in one direction. It appears to be supported on only two of the four sides, with a grade drop of several feet due to aggradation and degradation of the channel from one side of the column to the other. The column may also be stabilized by the beams connected to it.

Undermining of Center Column

The existing column will be utilized for this alternative. Given the extent of the undermining at the column, the existing beams would need to be shored prior to removing Beams 2 through 4. While the beams are being supported, a concrete skirt would be formed around the base of the column to repair the undermining. Concrete repairs would also be performed on the column above and below the waterline.

The new center column will be a cast-in-place concrete circular column to facilitate hydraulic flow and will be assumed to be founded on ledge (see discussion above). As all of the beams are being replaced, shoring will not be required.

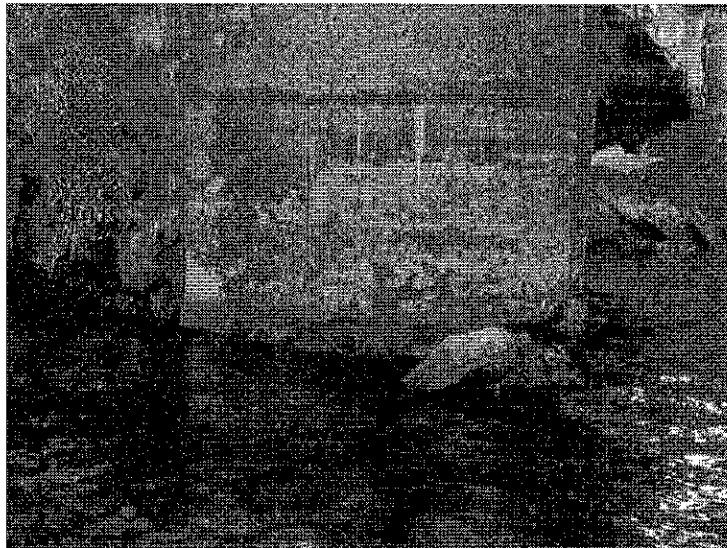
- The downstream pier is partially undermined and there is concrete deterioration at and below the waterline with section loss. Large rip rap placed during the bridge rehabilitation now covers this area. There are also delaminations and spalls at the face of the pier. A horizontal crack was repaired as part of the bridge rehabilitation project.

Deteriorated Concrete along the Waterline at the Downstream Pier

The upstream and downstream piers will also remain in-place with only concrete repairs for all alternatives. The concrete above the waterline appears solid and requires only minimal repairs, so once the abrasion of the concrete along the waterline and any undermining are resolved, the piers should be usable. The existing rip rap placed in the channel as part of the Brandon Arch Rehabilitation project will have to be removed to perform the repairs and then placed back into the channel once repairs are complete.

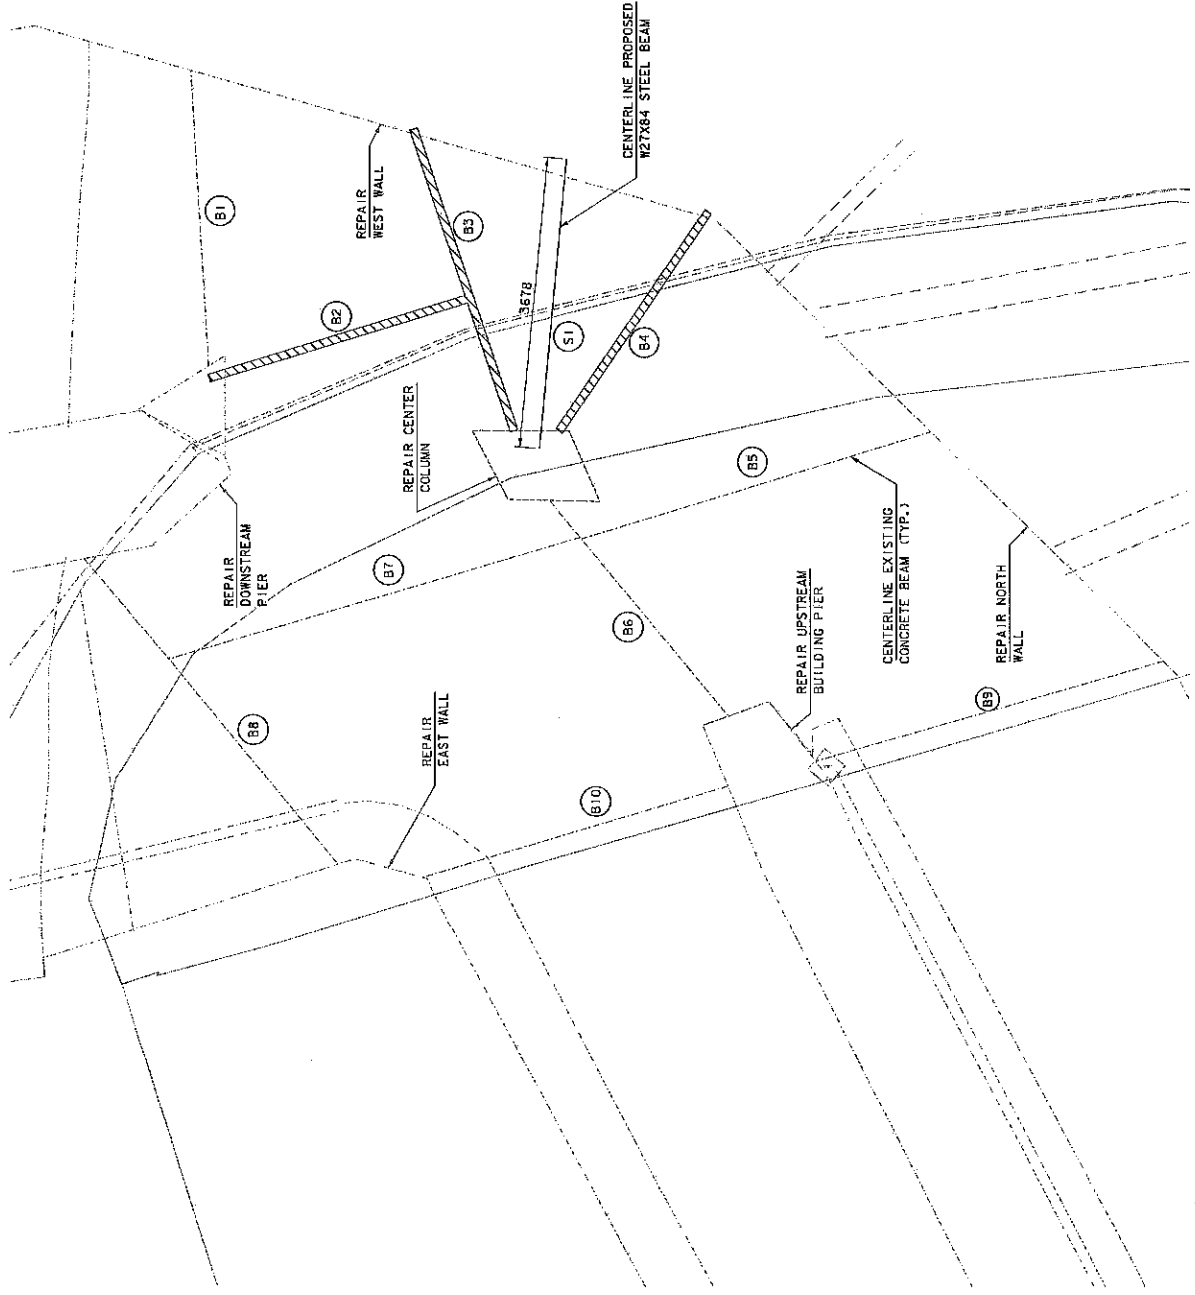
PLAN VIEW  
90 SCALE

As noted under the existing conditions section above, Beams 3 and 4 are in the worst condition of all the beams. The poor condition of the existing concrete combined with the uncertainties associated with the presence of multiple railroad tracks and the shear crack all indicate that the beams cannot be adequately repaired. Although Beam 2 does not appear to be in poor condition, due to the configuration of the beams and its connection to Beam 3, Beam 2 also needs to be removed. Therefore, this alternative would replace Beams 2 through 4 with a single steel beam connecting into the existing center column. Concrete repairs would be performed on the beams that remain in-place. Although concrete is more durable in damp locations, a galvanized rolled steel beam was chosen to minimize the load on the existing wall and to accommodate a quick fabrication period.

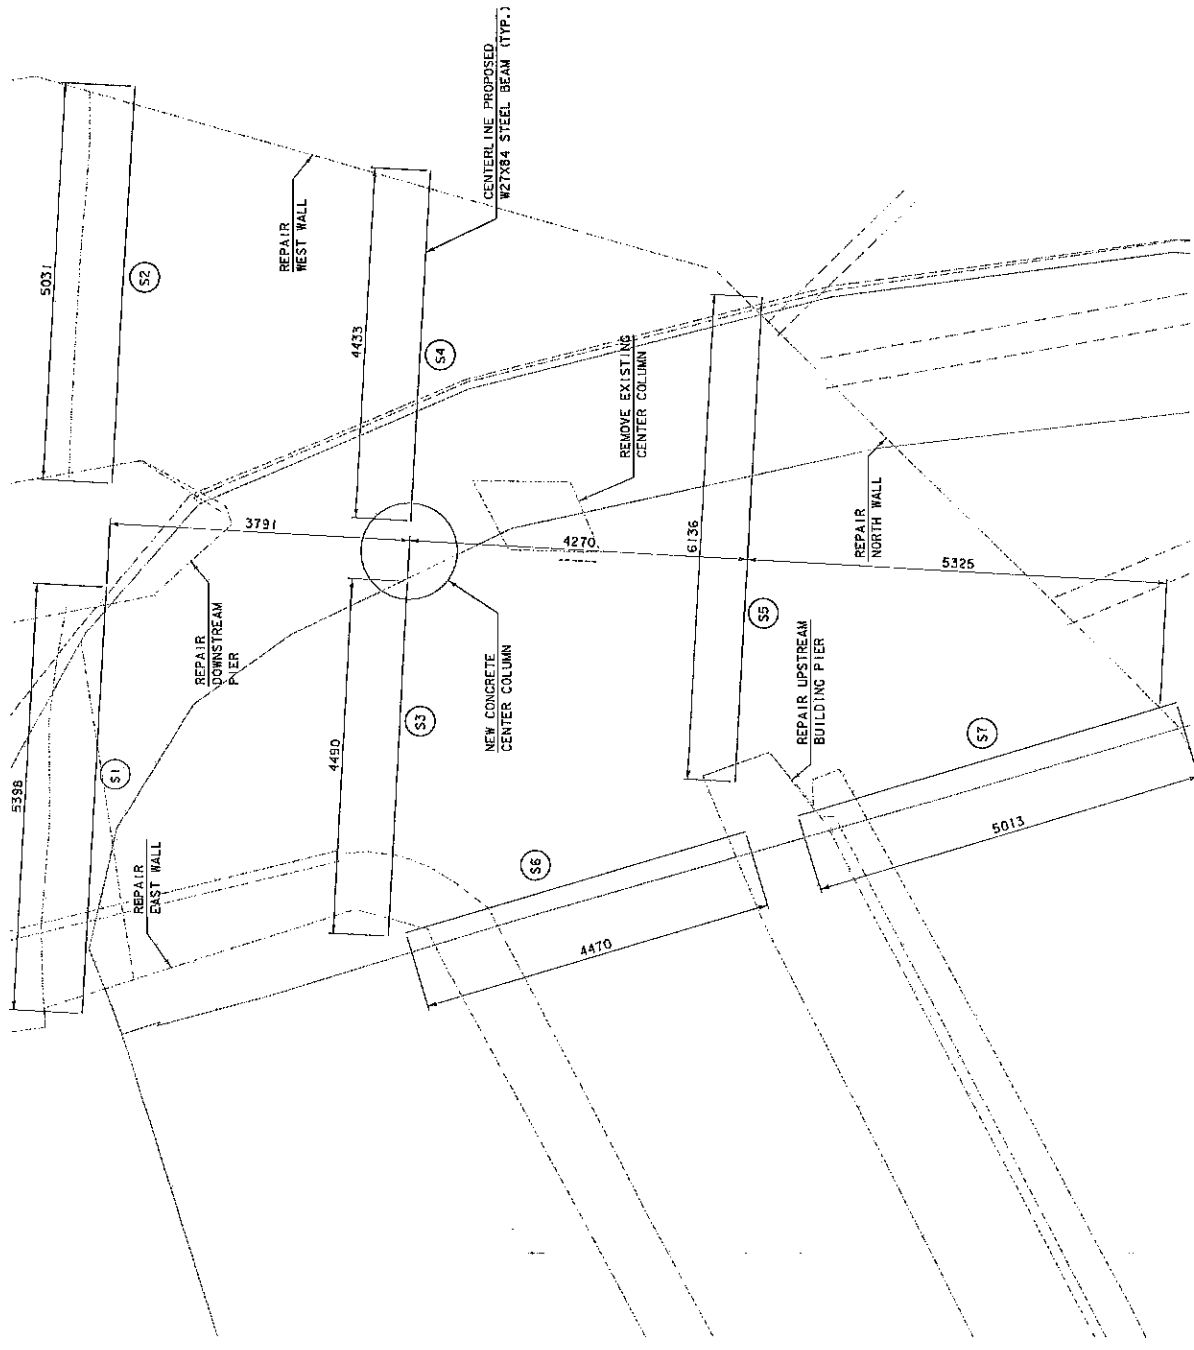
**PLAN VIEW**  
SCALE: 3/8"

Alternative 3 replaces all of the existing beams and the center column with an entirely new framing layout that simplifies the complicated geometry of the existing structure. Three lines of beams will be constructed and will consist of simply supported steel rolled beams. The first line will be constructed immediately upstream of the existing arch opening. It will consist of two beams, one supported by the east wall and downstream pier and the other supported by the west wall and the downstream pier. The second line will be constructed approximately 3.8 meters upstream of the first line and consist of two beams, one supported by the east wall and a new center column, and the other supported by the west wall and the new center column. The third line will be constructed approximately 4.3 meters upstream of the second line and will consist of a single beam supported by the upstream building pier and the north wall. Two additional existing beams at the downstream entrance of the two barrels of the channel underneath the Town Offices Building will also be replaced with two new steel beams.

Based on the review of risk, cost, constructability, construction duration, Fuss and O'Neill recommends Alternative 3. This option provides the greatest life span, thus eliminating the need for future repairs to the existing concrete beams. Future repairs will be considerably more difficult in the future as all work will need to be done from as the slab will be in place. Alternative 3 also eliminates the risk of continuing to use beams of unknown capacity. There are potential constructability issues with Alternate 2 when attempting to connect the existing beams to be reused to a new column but Alternate 1 reuses a significantly deteriorated column. Alternate 3 eliminates both of these risks.
